Manhole Inspection Summary

Manhole # S19OO1014MH

Location Address: **2020 BRAND AVE**

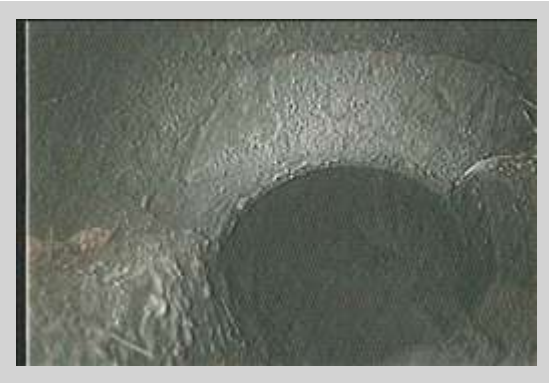
10 in. Circular Gravity Sewer Pipe Out @ 12 O'Clock

Pipe Material: **Clay** ☐ Pipe Lined

Invert Depth: **12.38** (ft.) Flow Characteristics: **Fast**

Deposits: ☒ None ☐ Mud ☐ Sludge ☐ Debris ☐ Grease

Infiltration: **None** Pipe Seal Cond: **Unknown**

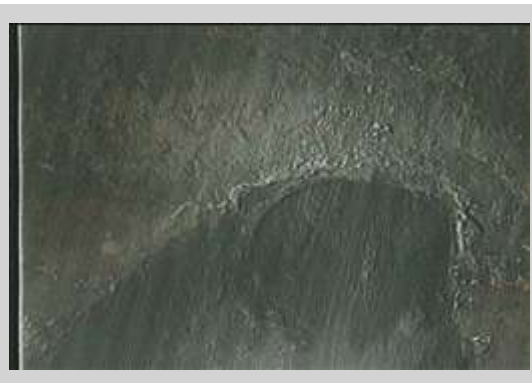
Drop In @ 7 O'Clock

Drop: **Outside** Rod and Bar

Angled: **Yes** Reading: **11.00** (ft.)

Drop Condition: **Open**
